TOPS Veterinary Rehabilitation

HydroFLOW Case Study: Hydro-Treadmill Therapy Pool

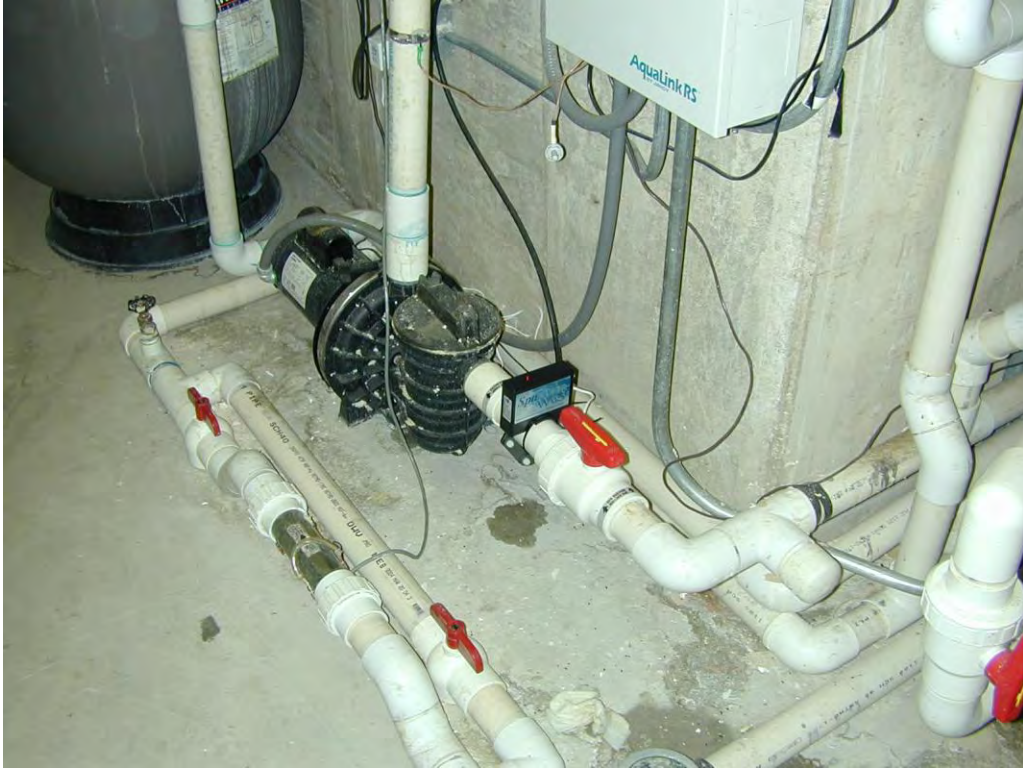
Photograph of installed *HydroFLOW* water conditioner

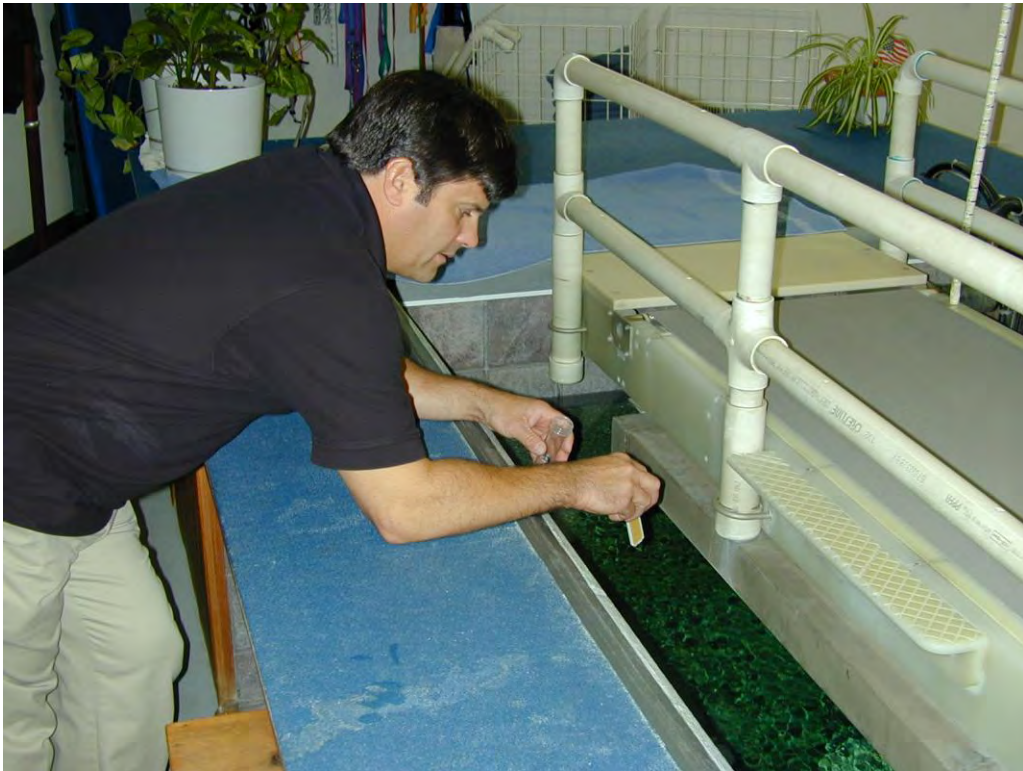
Photograph of Tom McCauley taking bio measurements using a dip slide

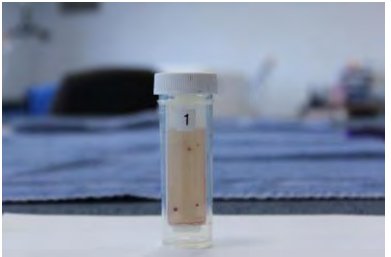
Condition	Picture	Assessment
<p>Baseline measurement. Pool water prior to backwash after evening shock the night prior.</p>

<p>Following normal protocol, (without <i>HydroFLOW</i> installed and normal chemical additions) our pool is essentially bacteria free. 5 colonies appeared.</p>
<p>Baseline measurement. Pool wall prior to backwash and after evening shock the night prior.</p>

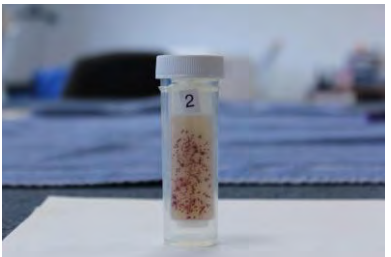
<p>Following normal protocol, (without <i>HydroFLOW</i> installed and normal chemical additions) our pool wall shows many colonies.</p>
<p>Prior to <i>HydroFLOW</i> installation. This reading therefore is after the pool water has stabilized (pH, etc.) following the backwash. Expected result is minimal colonies.</p>

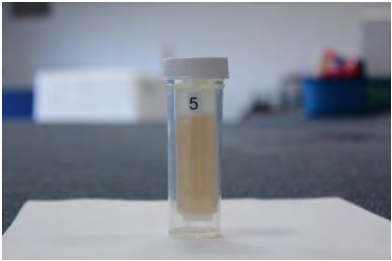
After two weeks with *HydroFLOW* and normal chemical dosage, but without additional backwash having taken place. **This tests if the *HydroFLOW* system has any negative effect on bacteria levels and also gives us a baseline with the *HydroFLOW* system but without a chemical reduction.**

Test shows that the *HydroFLOW* had not increased bacteria levels. No colonies appeared. ** Note, test 5 eventually developed 10 colonies. I happened to look at the slides on 3/15 (5 days post dip), and noted that all the other dips tests hadn't changed, but this one went from 0 to 4.

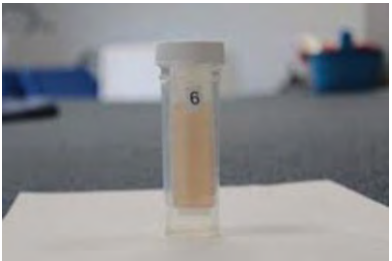
After four weeks with *HydroFLOW* and normal chemical dosage, but without additional backwash having taken place.

Test shows that the *HydroFLOW* had not increased bacteria levels. No colonies appeared, even as the date elapsed since the prior backwash continued to grow.

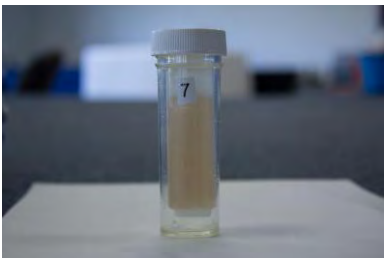
After six weeks with *HydroFLOW* and normal chemical dosage. Backwash and chemical reduction taking place next.

Test shows that the *HydroFLOW* had not increased bacteria levels. No colonies appeared, and the elapsed time between previous backwash has reached its maximum. No effect on filter pump pressure was seen.

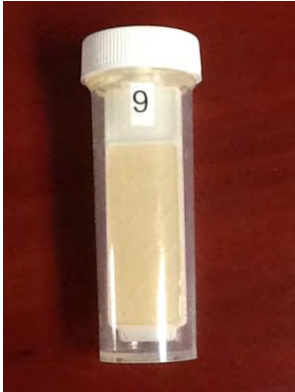
<p>After 1.5 weeks with chemical reduction of 50% and Copper system turned off (9.5 weeks into the test).</p>

<p>Although our intention was to reduce chemicals by 25% this test shows further reductions to 50% of our (normally low anyway) still maintain a bacteria free presence with the <i>HydroFLOW</i> system in place.</p>
<p>Conclusion of test pool wall test. We did not expect dramatically different results than start of test, due to the bacteria harboring nature of the pool plaster.</p>

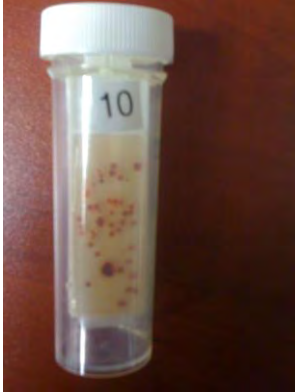
<p>There is a definite improvement in the amount of bacteria on the pool walls as a result of the <i>HydroFLOW</i> system being in place. We expect further reductions to take place as time passes.</p>
