## Case Study - Hotel Cooling Tower - Scale and Bio

Marriott Koolina Beach Club, Oahu, Hawaii, USA.

500 Ton Cooling Tower.

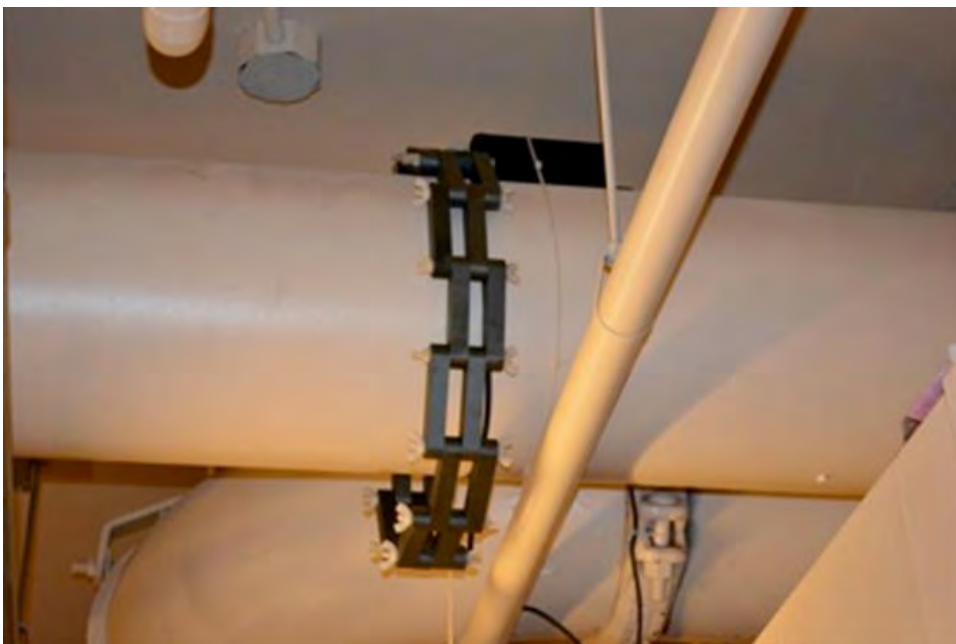
**Installed HydroFLOW water conditioner:**

*HydroFLOW* Custom 14" water conditioner on a cast iron pipe feeding the chillers.
